REPORT OF INVESTIGATION

Surface Nonmetal Mine
(Granite)

Fatal Falling or Sliding Material Accident
August 27, 2005

Albert Frei & Sons, Inc.
Walstrum Mine
Idaho Springs, Clear Creek County, Colorado
Mine I.D. No. 05-03935

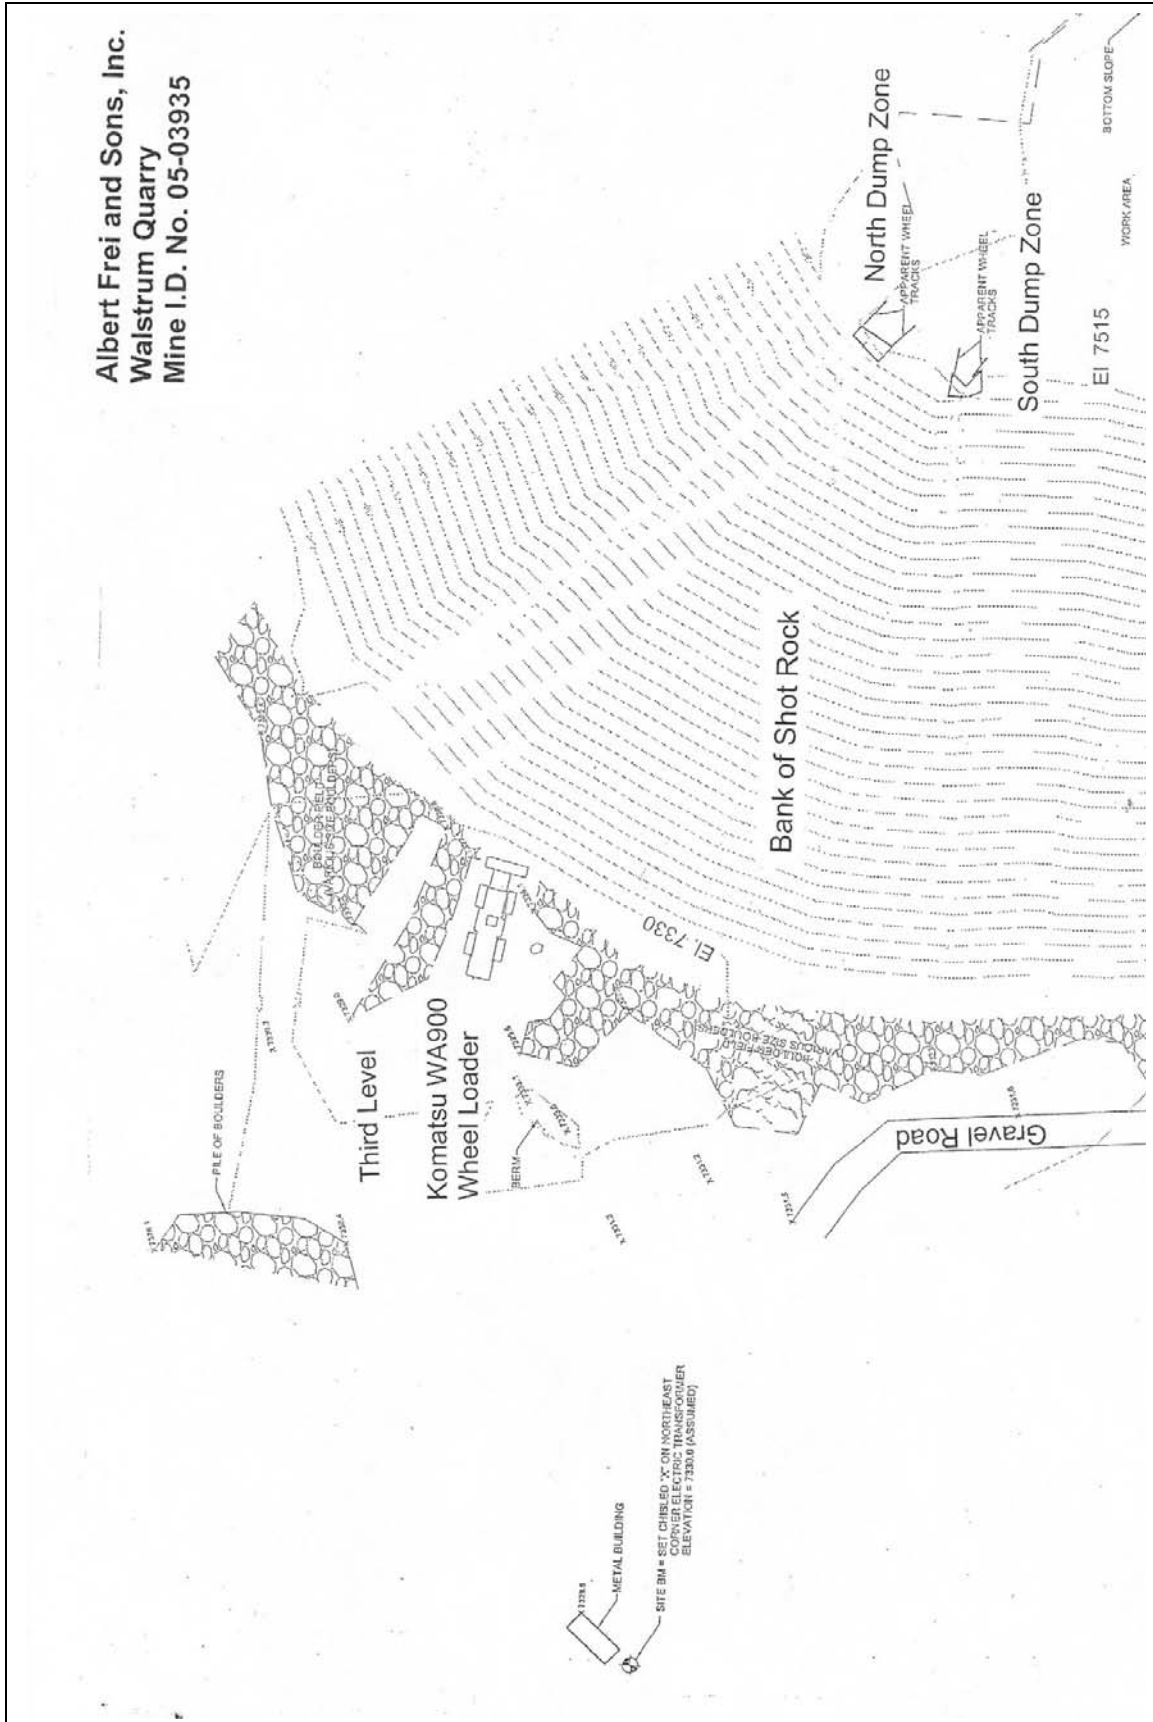
APPENDIX B

The accident occurred at the toe of the east highwall on the third bench. The east highwall consisted of several benches that started at the third bench and rose 185 feet to the fifth bench.

Each dump location had a channel running down the bank where most of the rock flowed. Rocks, which were dumped at the north and south dump areas, were observed out as far as 80 feet from the toe of the bank on the third bench. In order to load out all of the deposited rock, the loader on the third bench cleaned this area to the toe of the bank. Large rocks typically came to rest about 30 to 40 feet out from the bank. In addition, the rock spread laterally over a distance of more than 150 feet when deposited from each location.

There was no evidence that the loader cut into the toe of the bank or that there was any mass instability of the bank at the accident site. Numerous rocks were observed lying very loosely on the slope of the bank. Even when there was no mining activity at the top or bottom of the bank, small rocks were observed rolling or sliding down the bank.
